Research Article

Impacts of Furrow Irrigation on Shesher and Welala Natural Reservoirs of Lake Tana Sub Basin, Ethiopia

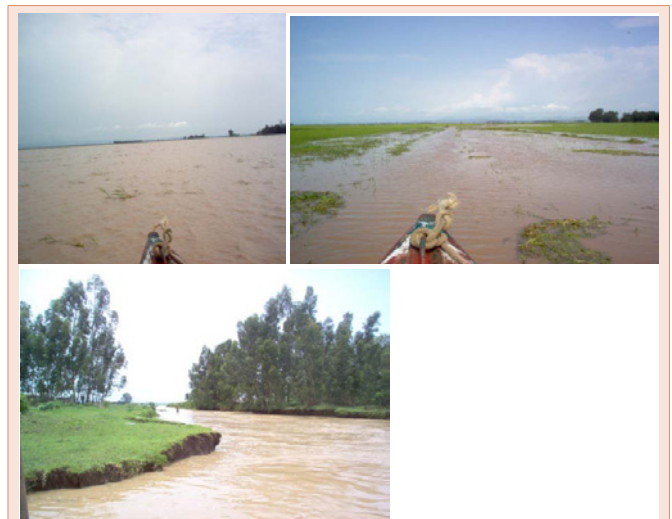
Figure 2: Shesher reservoir during rainy season, and joining Lake Tana from left to right (Photo: Dereje Tewabe, 2012).

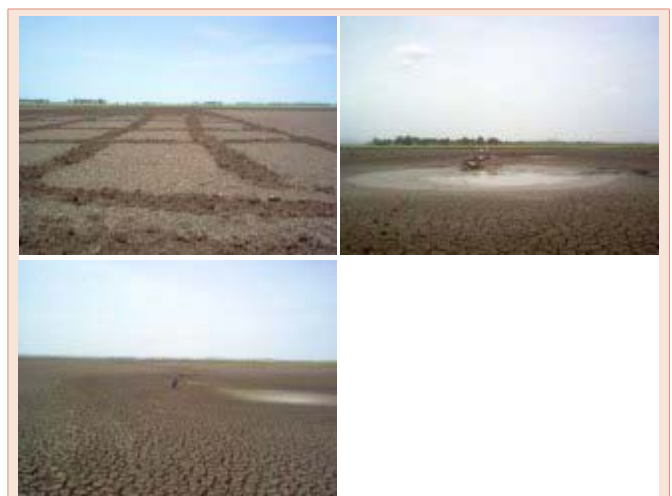
During pick dry season of March, 2012 the survey showed unexpected, amazing and sudden death of a home for many biodiversity and life full of Shesher natural resource dried up totally and birds fetch their food from remnants small shrieked wet mud spot (Figure 3). This happened due to several and unlimited human encroachments for different activities mainly for crop cultivation, with out any rules and regulations. Major crops cultivated by drained Sheshers water using gravitational force were *Eragrostis teff*, Cheak pea, Lentils and Safflower (Figure 4). It seems the community lacks knowledge and awareness about Shesher reservoir wetland of sustainable use other than exploiting beyond its maximum limit.

Figure 3: Total dried up of Shesher reservoir with shrieked mud aggregated by birds at the center.

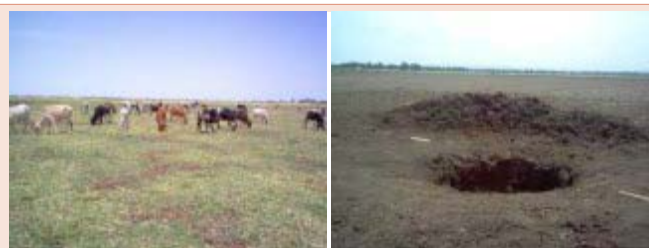
6). Water could not be found even for drinking of their animals and for themselves, as a result they started digging of the ground to fetch water for themselves and their animals (Figure 7).

Figure 7: Digging ground water (Well) at the center of Shesher reservoir for their animals after complete dried up of the reservoir.

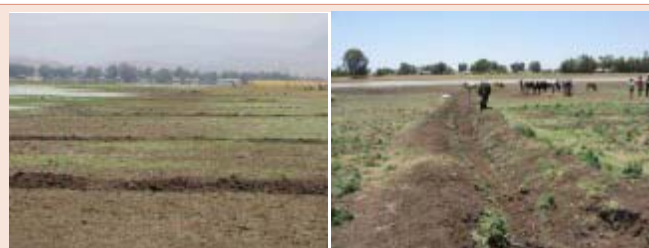
Figure 8: Furrows of Welala reservoir with 50 m intervals at both sides of farm lands to irrigate their crops.

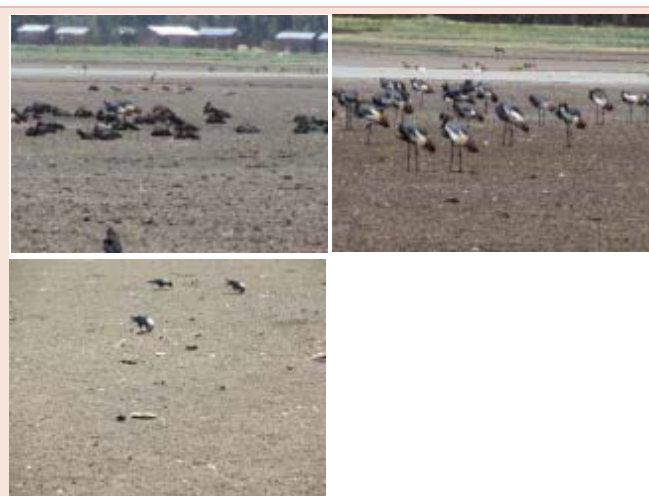
Especially fishes and birds are seriously affected during the pick dry seasons of the area and it is not uncommon to see remnant dead fishes eaten by birds (Figure 9). If Welala wetland could be protected from several imposed activities from the inhabitants it might be properly exploited by designing appropriate interventions for instance it can serve for fisheries and ecotourism activities (Figure 10).

Figure 9: Highly populated birds and remnant dead fishes eaten by birds in the highly shrunk and almost dried Welala wetlands.

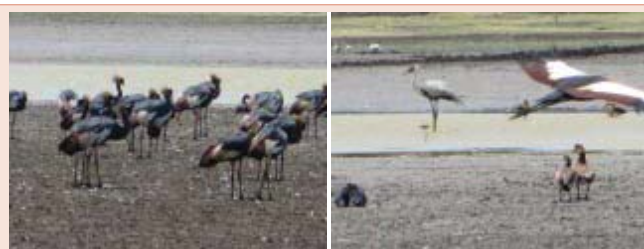
Figure 10: Ecotourism and fisheries are assumed to be an appropriate intervention in Welala wetlands of lake Tana.
